REPAIR, REHABILITATION AND RETROFITTING OF ELEVATED STORAGE RESERVOIR (ESR) SITUATED AT THANE FOR THANE MUNICIPAL CORPORATION- A CASE STUDY

Author: Mr. Suresh Sahu

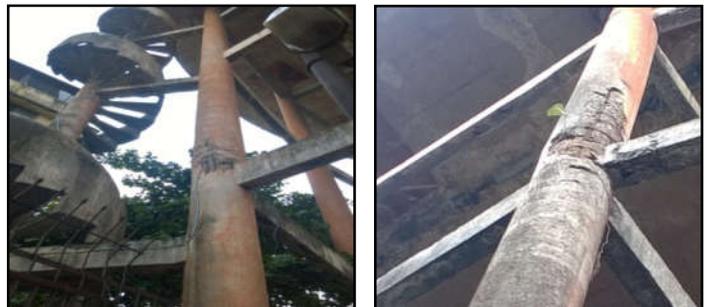
Fig.2&3: Observations

During our survey, we have observed lot of cracks and crazing on the external plaster of the ESR. Heavy Leakages

were observed on the bottom of the tank. Steel exposure was observed on various RCC columns and beams indicating the severity. Reinforcement bars of certain Columns are found

exposed and even at some places found missing indicating the rate of corrosion is very high. The beams connected to the Service staircase also appeared with lot of major cracks. Cracks were observed on the staircase causing steel exposure. On the external surface of the sump house, lot of cracks and crazing was observed. The water proofing of the RCC Chhajjas was found to be failing gradually. The water proofing of the roof of the sump house is also found to be dilapidated. The overhead waterproofing of the underground water tank was observed to be in distress.
