REPAIR, REHABILITATION AND RETROFITTING OF ELEVATED STORAGE RESERVOIR (ESR) SITUATED AT THANE FOR THANE MUNICIPAL CORPORATION- A CASE STUDY

Author: Mr. Suresh Sahu

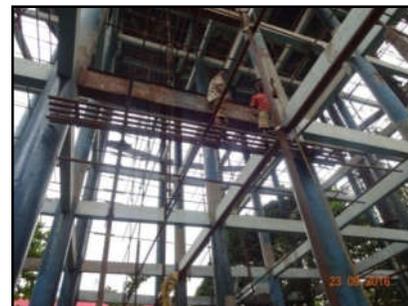
Fig.6 Erection of scaffolding

The joint between the R.C.C members and brick work were treated with Chicken wire mesh and PMM at the external surface. Crack bridging and anti carbonation treatment was applied on the external part of the ESR.
